PB91-916501
NTSB/PAR-91/01

PIPELINE ACCIDENT REPORT

LIQUID PROPANE PIPELINE RUPTURE AND FIRE
TEXAS EASTERN PRODUCTS PIPELINE COMPANY
NORTH BLENHEIM, NEW YORK
MARCH 13, 1990

ADOPTED: JUNE 11, 1991

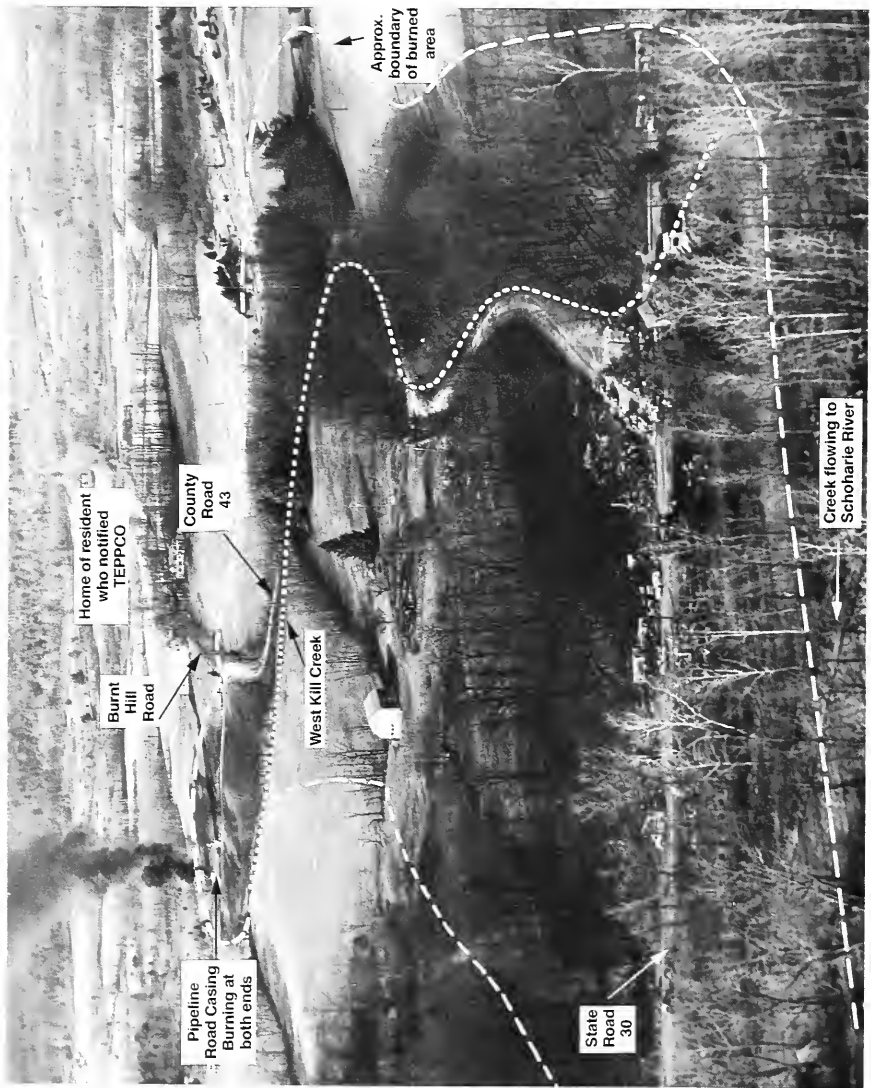
Figure 1.--Aerial view of the accident area.

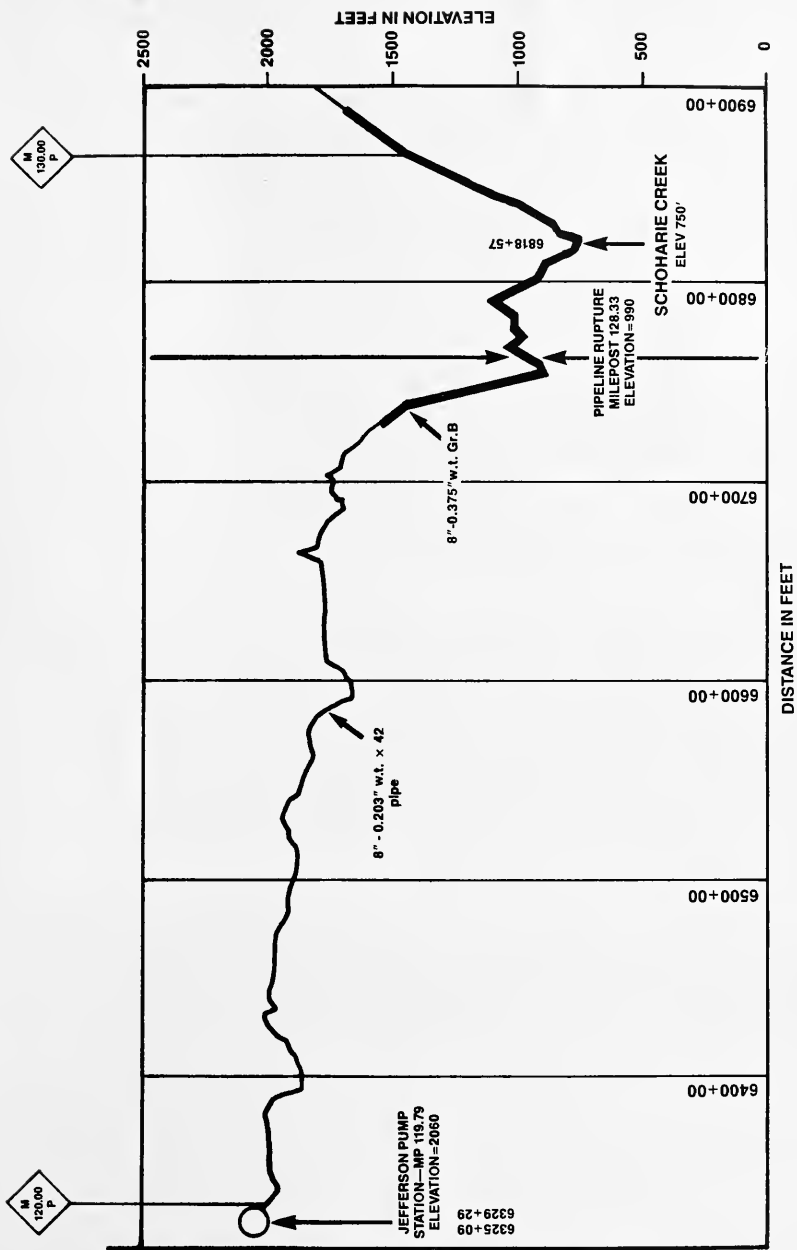
Figure 3.--Pipeline profile showing the location of the rupture.

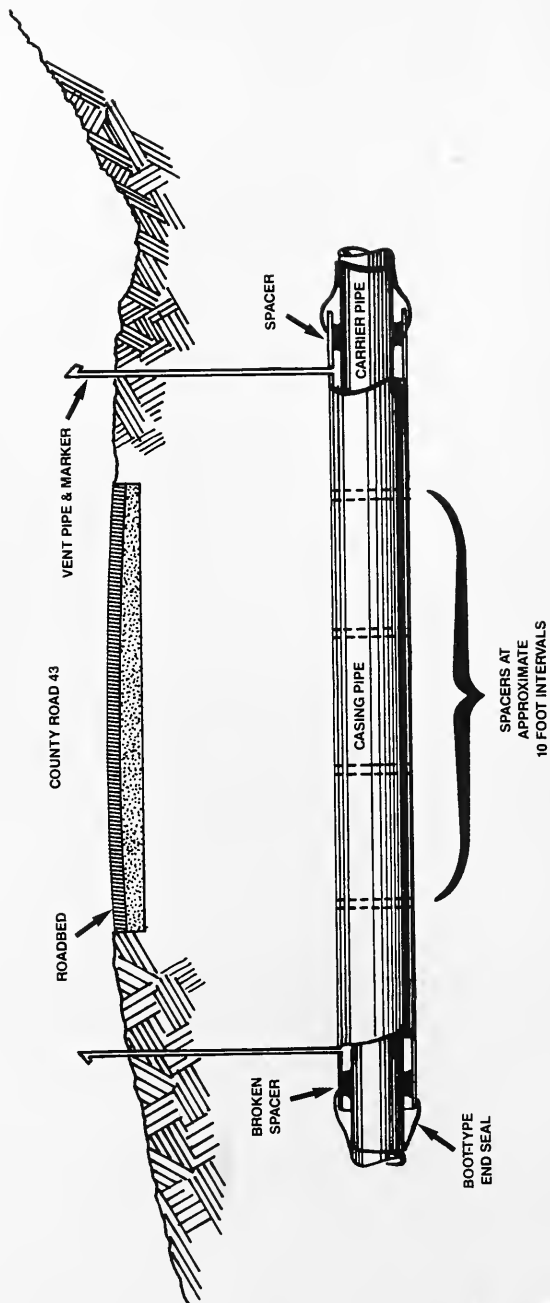
Figure 4.--Cross sections sketch of pipe crossing CR 43, Looking North.

near the midpoint of the trench, about 30 feet west of the casing. In the midpoint bell hole, the crew placed a wooden timber (skid) on the soil below the pipe and positioned a hydraulic jack between the skid and the pipe. They raised the pipe several inches to obtain clearance (about 2 inches) between the pipe and the west end of the casing. The crew temporarily supported the pipe on skids, excavated another bell hole nearer the casing, and jacked the pipe upward at that location.

The crew then removed the broken insulator, but did not install a replacement. The maintenance supervisor stated that he did not believe there would be room to install both a spacer and a casing seal without blocking the casing vent line. They used 12 synthetic rubber links that were obtained from TEPPCO's supply inventory when the work was assigned, joined them into a "belt" using bolts, placed the belt around the pipe at the casing, connected its loose ends with a bolt, and positioned the assembly in the annulus between the pipe and the casing. The maintenance supervisor stated that he had not previously used these links to seal a casing annulus and had never been instructed in their use. He added that he used his "common sense" to complete the installation. In an alternating pattern, he tightened the bolts connecting the individual links until he thought the links had been expanded enough to provide a water-tight closure of the annulus. The maintenance supervisor believed that this installation would both seal the annulus and substitute for the broken insulator. The manufacturer's instructions for installing these links, which had not been provided to the crew, advised that the links should not be used to support the pipe and that the bolts should be sequentially tightened.

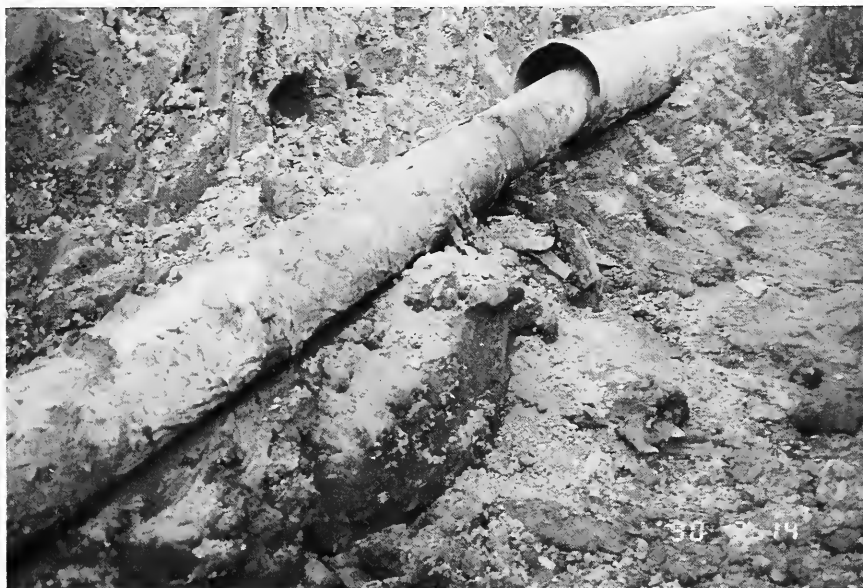
downward at a four-degree angle. The pipe had no bends as it exited the casing and was buried about 6 feet below the surface. It exited the casing to the west at a downward angle about 3 1/2 degrees relative to the casing. (See figure 6.) Other than fire and rupture damage, no other damage was visible. At the point where the pipe exited the casing, it was in contact with the bottom of the casing. The link seal, installed in February, was found about 3 feet from the end of the casing, and one of the links was broken. No evidence was present of select backfill (such as sand), sand bags, or other support for the carrier pipe except for the single, wooden skid that had been installed on February 21, 1990.

Figure 6.--View of the excavated pipeline showing its position relative to the casing at the west end.

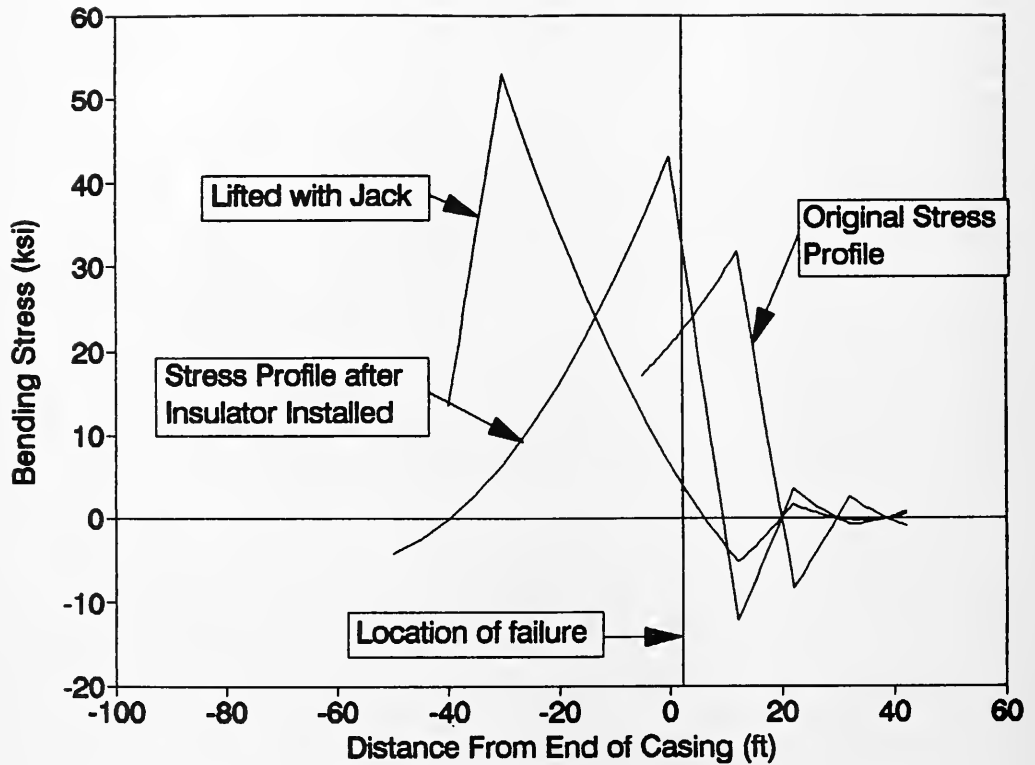
Stress Analysis.--Battelle performed a series of two-dimensional finite-element analyses to estimate the magnitude of the bending stresses in the pipe before, during, and after the repair work. Assumptions had to be made about the original pipe's raised positions and soil conditions. The analyses considered only bending stress. The calculations did not take into account any values for residual stress or axial stress from pressurization; these would have to be added. The analyses indicated that when the pipe was initially raised to remove the broken casing spacer, the maximum bending stress on the pipe increased from about 32,000 psi to about 53,000 psi. In addition, the point of the maximum stress moved from a few feet within the casing to about 30 feet west of the casing, where the jack lifted the pipe. After the link seal was installed in the annulus and the pipe lowered, the maximum bending stress was reduced to 43,000 psi at the end of the casing. At the point of failure, the bending stress was less than the maximum stress. (See figure 7.) The Battelle analyses indicated that the bending stress at the point of failure decreased from about 22,000 psi to 4,000 psi when the pipe was initially raised and increased to about 32,000 psi after the repair work. The net effect of the repair work performed on February 21, 1990,

Figure 7.--Battelle's bending stress profiles showing the stresses before, during, and after repair.

increased the bending stress by 45 percent at the point of failure. These analyses also considered the effect of settlement after the repair on the pipe, and with a settlement of 15 inches, the increase in the bending stress at the failure would have been about 10,000 psi.
